I. Persons Giving Notice

IV. Dates and Description of the CWA Violations

Subject: Johnson Ranch -- Channel Blockage Downstream of Channel A

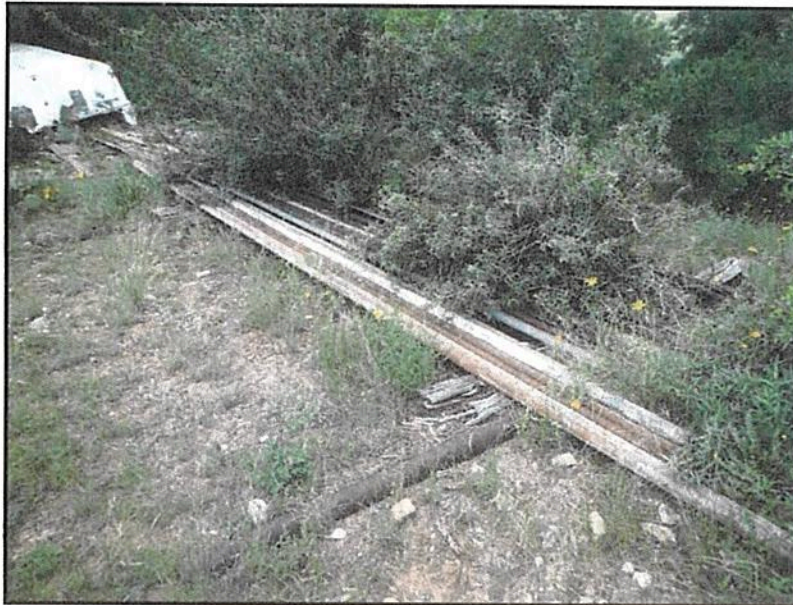
Figure F-8. Photo of abandoned pipes at dumpsite along west bank of the drainage.

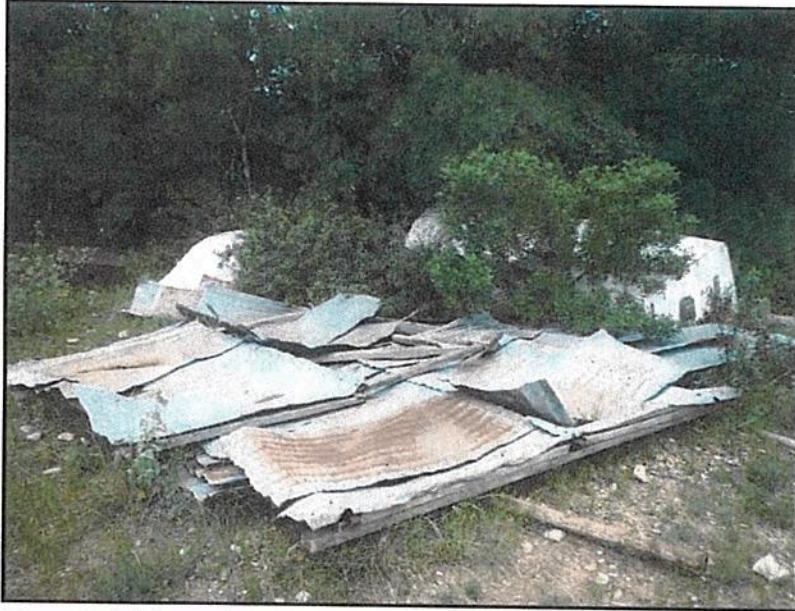
Figure F-9. Photo of corrugated metal and overturned fiberglass boat at dumpsite along west bank of the drainage.

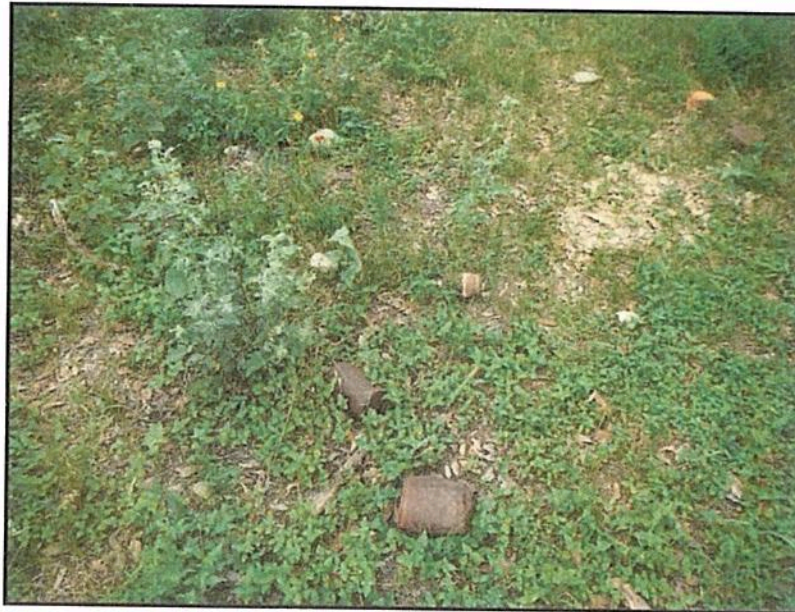
Figure F-10. Photo of several used vehicle oil filters at dumpsite along west bank of drainage.

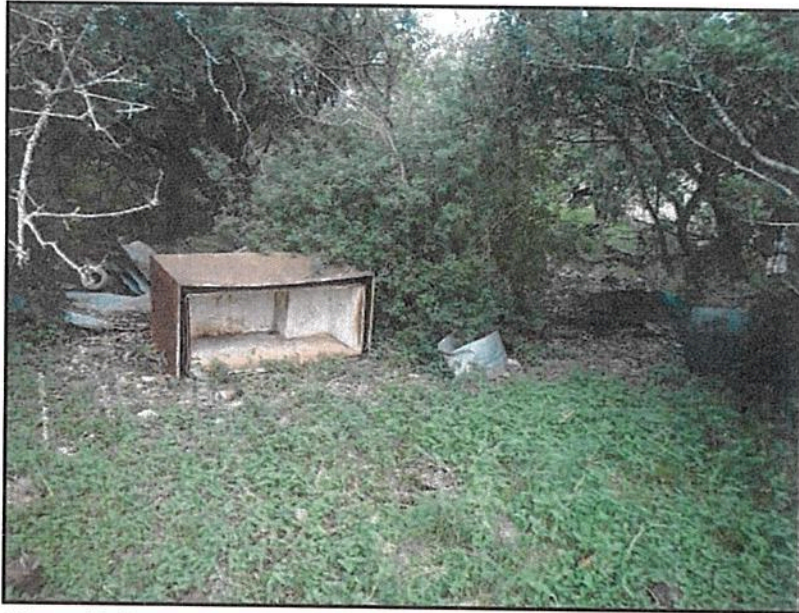
Figure F-11. Photo of abandoned refrigerator, scrap/corrugated metal, and possible water heater at dumpsite along west bank of drainage.

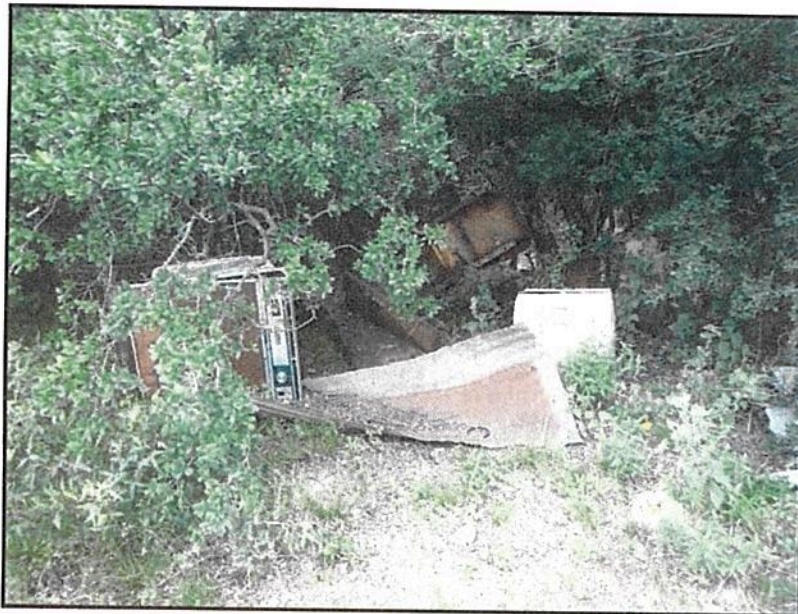
Figure F-12. Photo of abandoned dishwasher and other appliances and rusted scrap metal at dumpsite along west bank of drainage.

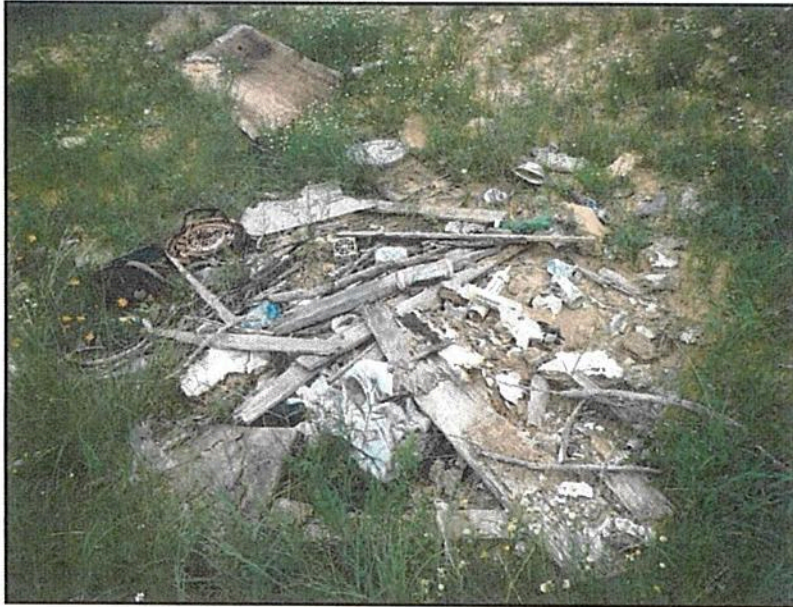
Figure F-13. Photo of miscellaneous items, such as wood, aluminum cans, metal and plastic scrap, and caulk tubes at dumpsite along west bank of drainage.

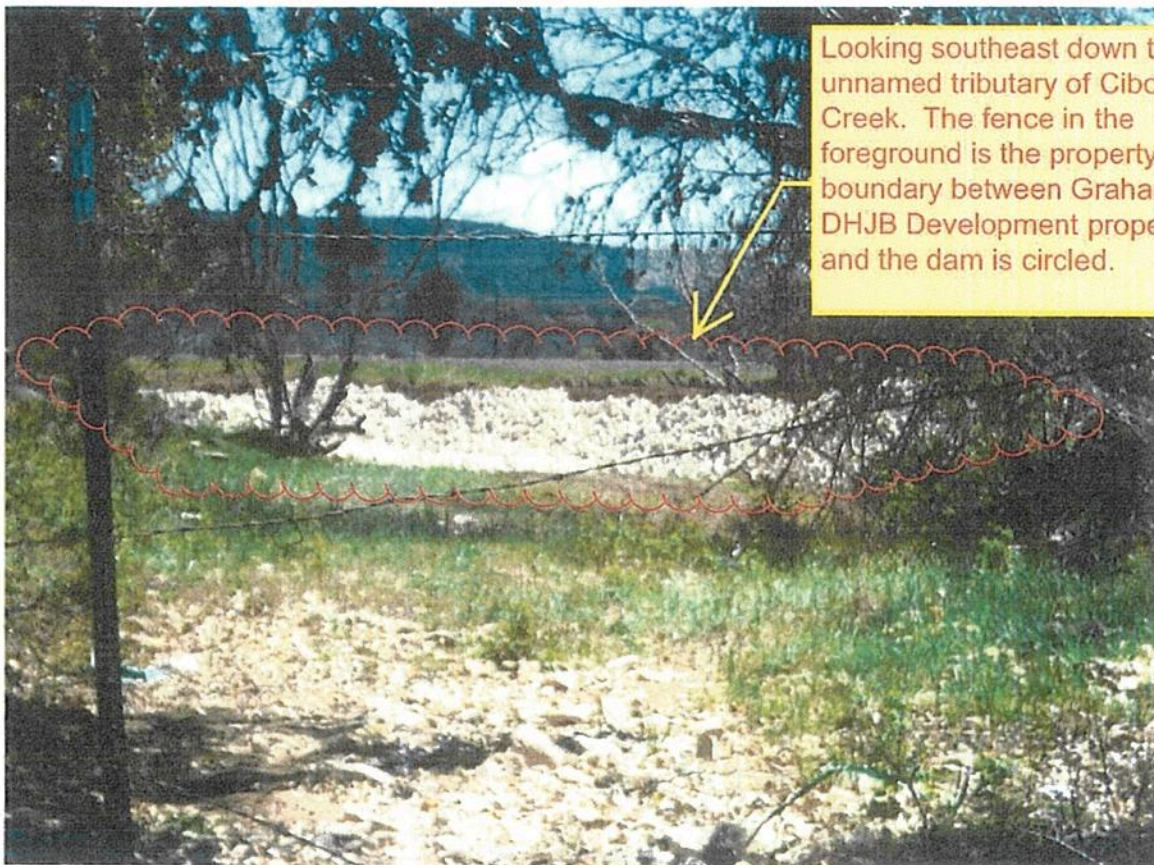
SUBJECT:	<u>Looking downstream</u>		
LOCATION:	<u>Unnamed tributary of Cibolo Creek off of Highway 1863</u>		
CITY:	<u>Bulverde</u>	COUNTY:	<u>Comal</u>
DATE:	<u>04/14/2014</u>	GPS:	<u>29.752262, -98.417028</u>
PHOTO NO.:	<u>2</u>

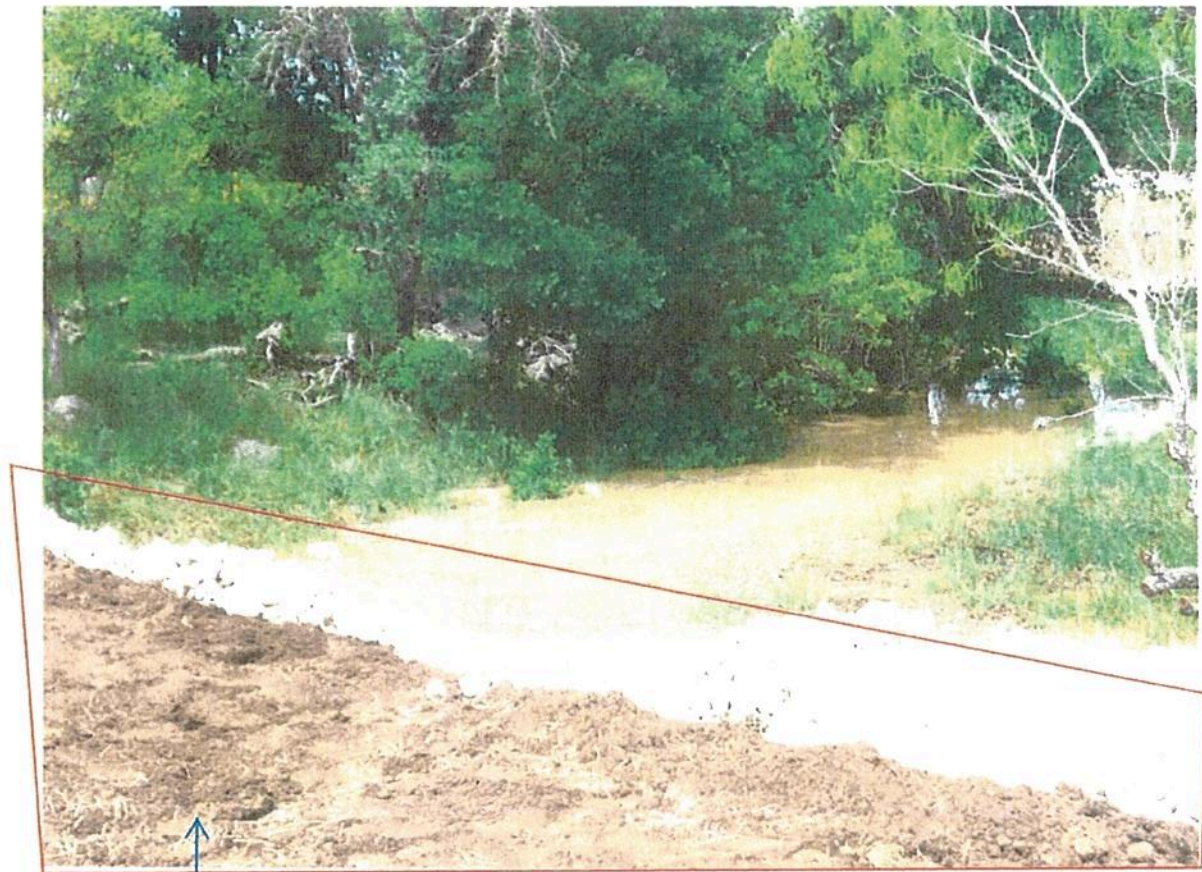
SUBJECT:	Earthen dam impounding water		
LOCATION:	Unnamed tributary of Cibolo Creek off of Highway 1863		
CITY:	Bulverde	COUNTY:	Comal
DATE:	04/14/2014	GPS:	29.752262, -98.417028
PHOTO NO.:	1

Standing on Dam (photo taken by TCEQ)
looking northwest at water backing up

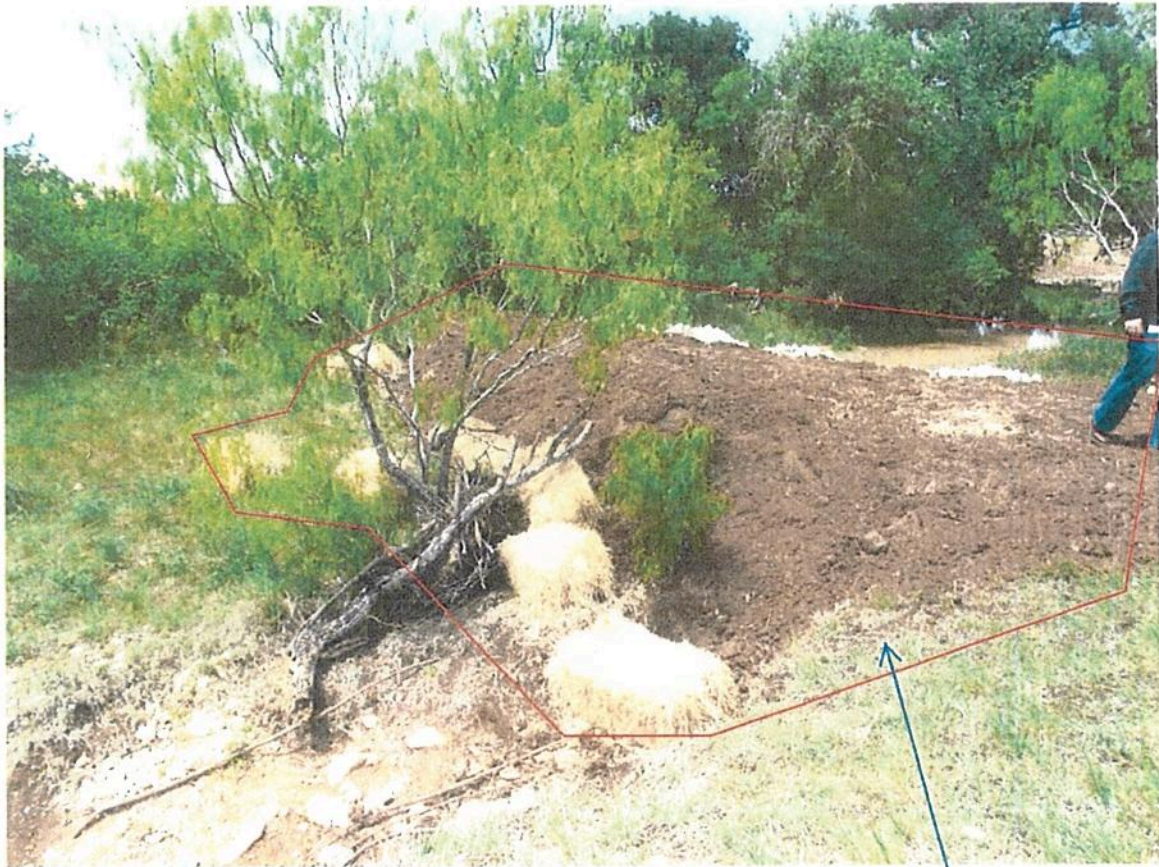
SUBJECT: Front of earthen dam
LOCATION: Unnamed tributary of Cibolo Creek off of Highway 1863
CITY: Bulverde COUNTY: Comal
DATE: 04/14/2014 GPS: 29.752262, -98.417028
PHOTO NO.: 1

This material was placed in the creek channel by Graham; most of this material has since washed downstream

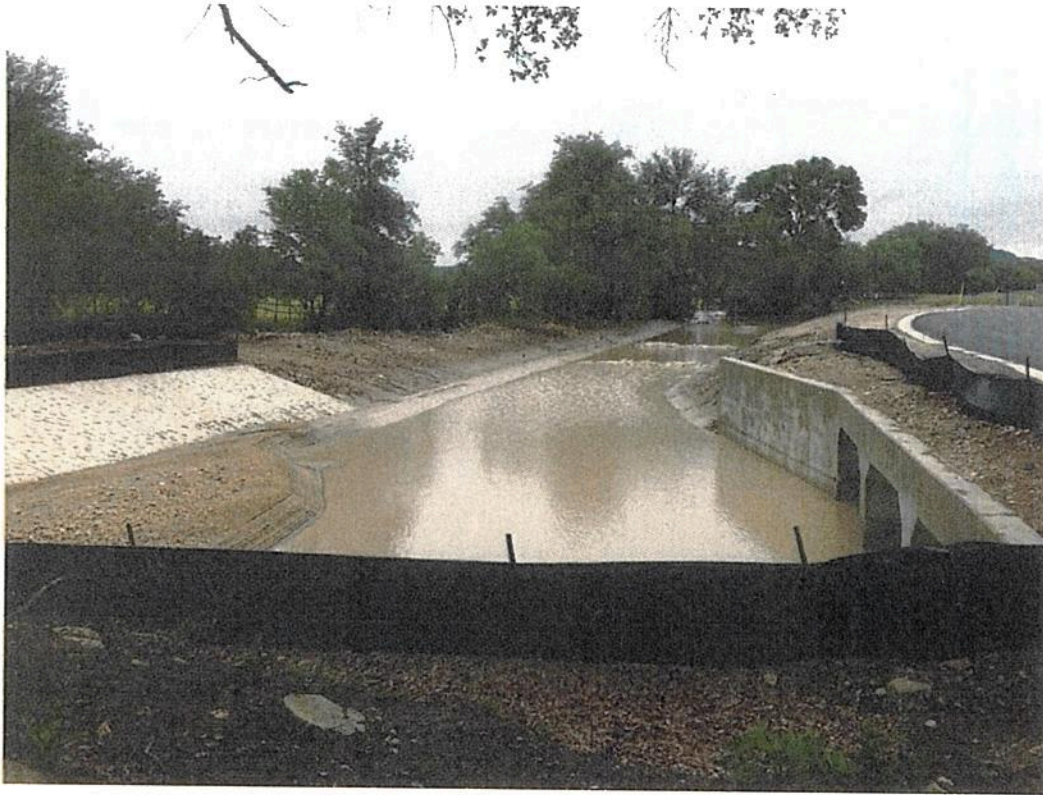
The majority of the southern portion of the Johnson Ranch subdivision drains to Channel A, paralleling Johnson Way, and leaves the property at a point approximately 2,100-ft north of FM 1863. In recent site visits at Johnson Ranch, I have observed that the natural channel downstream is blocked. From appearances, the downstream property owner has filled the natural channel with dirt and rock in an attempt to construct a dam to block water from leaving the Johnson Ranch property. See photo here illustrating the dam in the creek channel in relation to the property boundary:

Photo 1: Looking downstream at water backing up from Graham property.

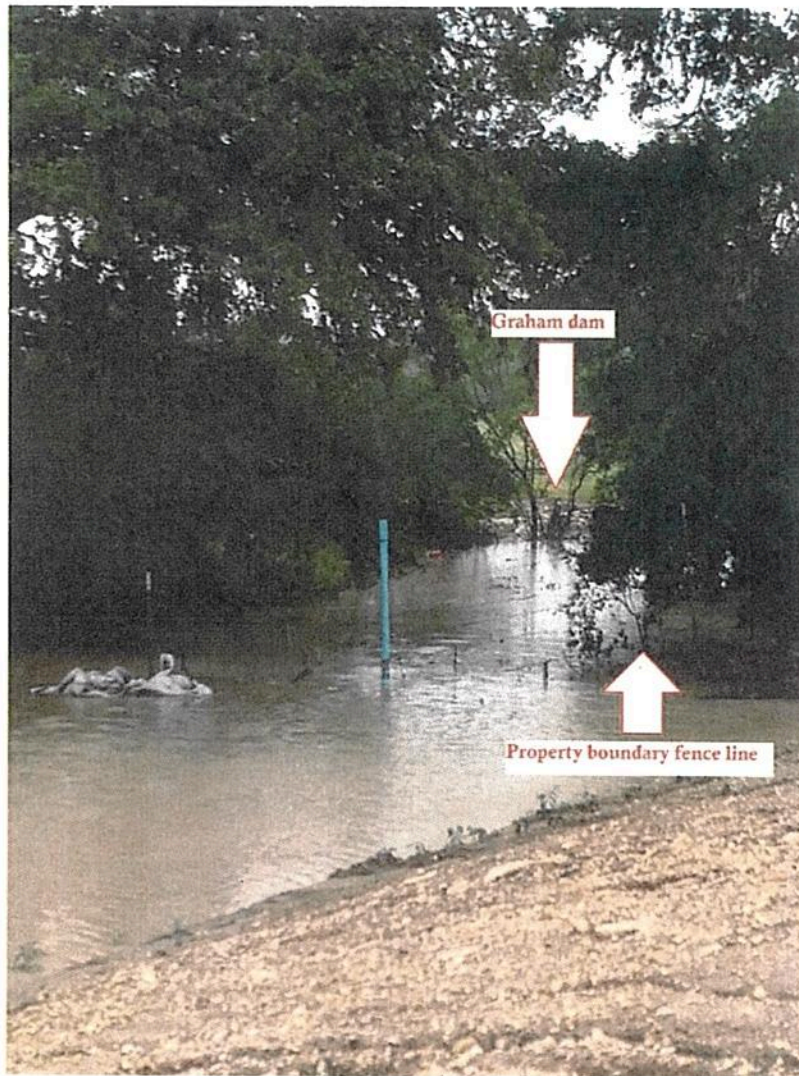
Photo 2: Looking downstream near property line at water backing up.

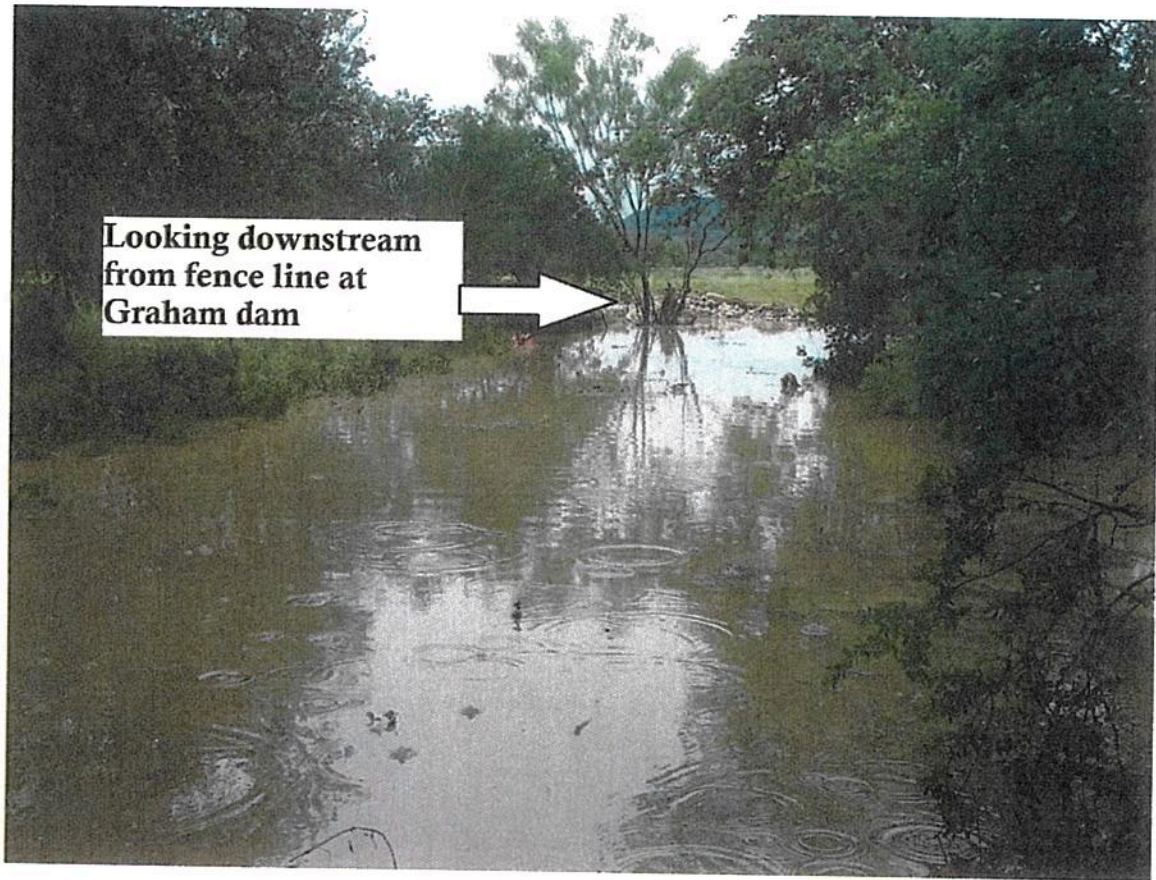
Photo 3: Photo looking downstream at dam from property line.

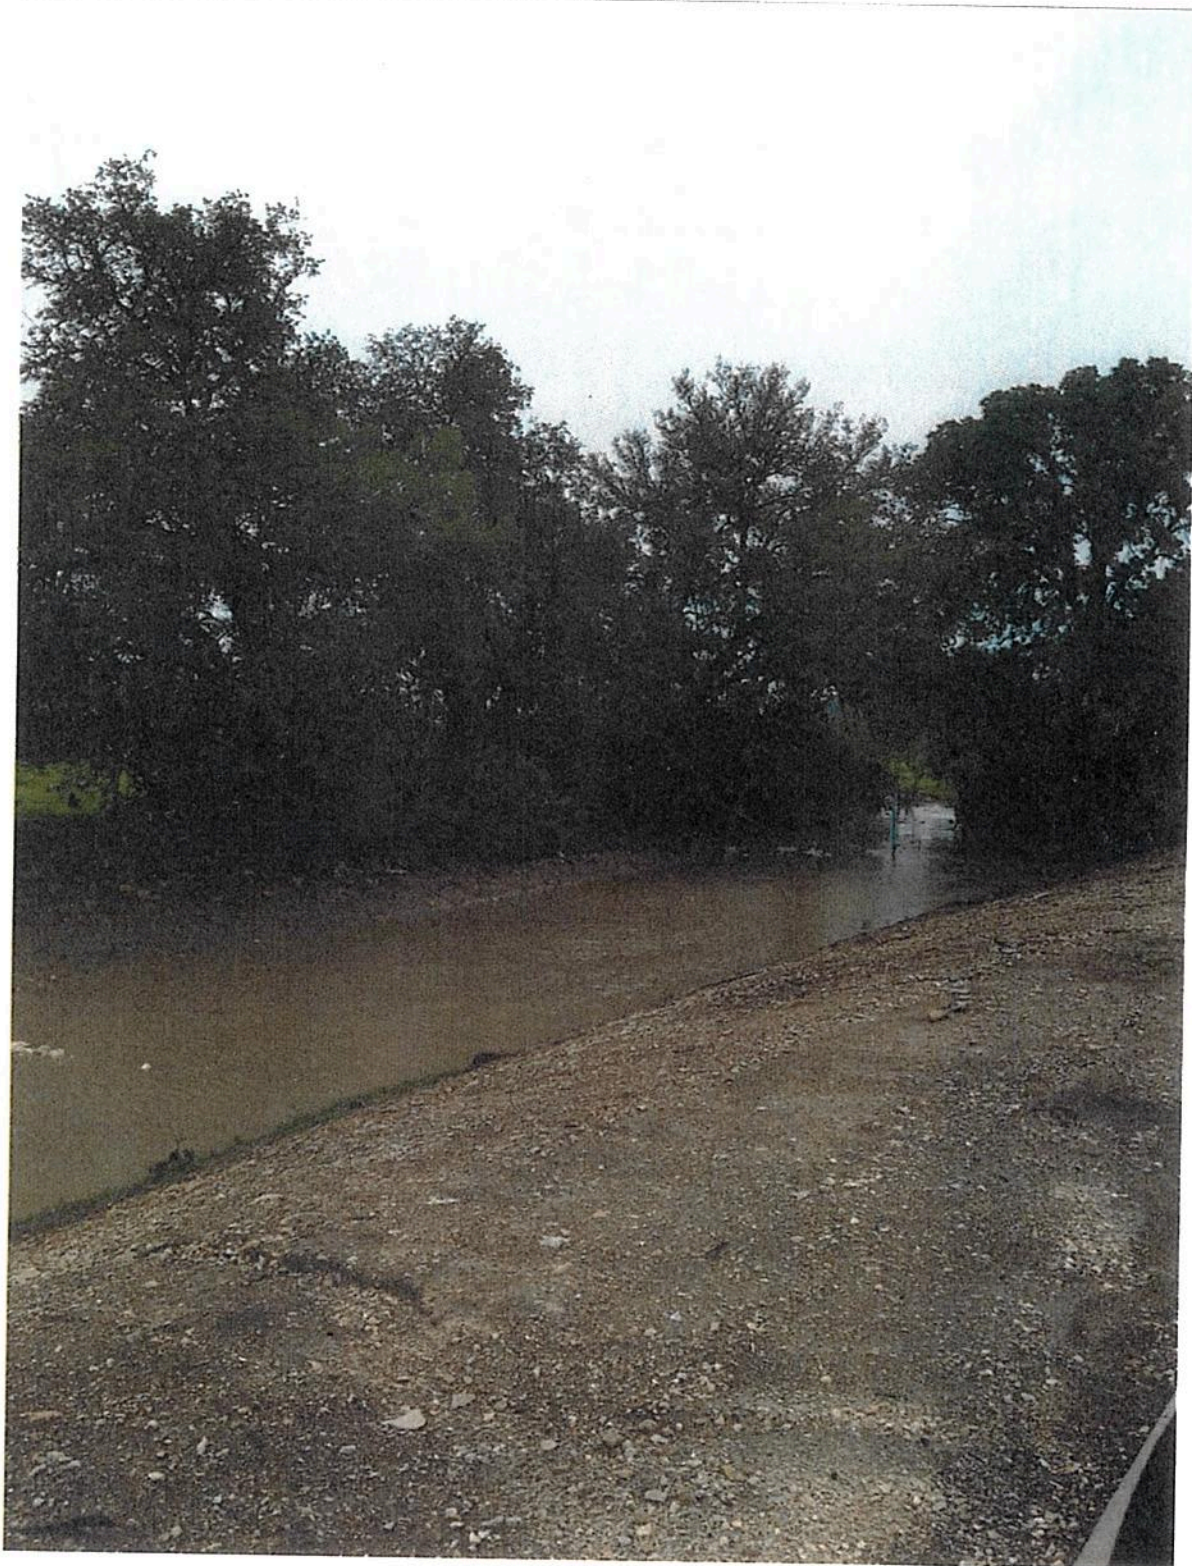
Photo 4: Additional photo of water backing up onto DHJB property from Graham's dam.
